State of Nevada
Department of Health & Human Services
Division of Child & Family Services
Southern Nevada Child & Adolescent Services
Facility Condition Analysis

SOUTHERN NEVADA CHILD & ADOLESCENT SERVICES

6171 West Charleston Blvd.
Las Vegas, Nevada 89146

Site Number: 9991
STATE OF NEVADA PUBLIC WORKS DIVISION
FACILITY CONDITION ANALYSIS

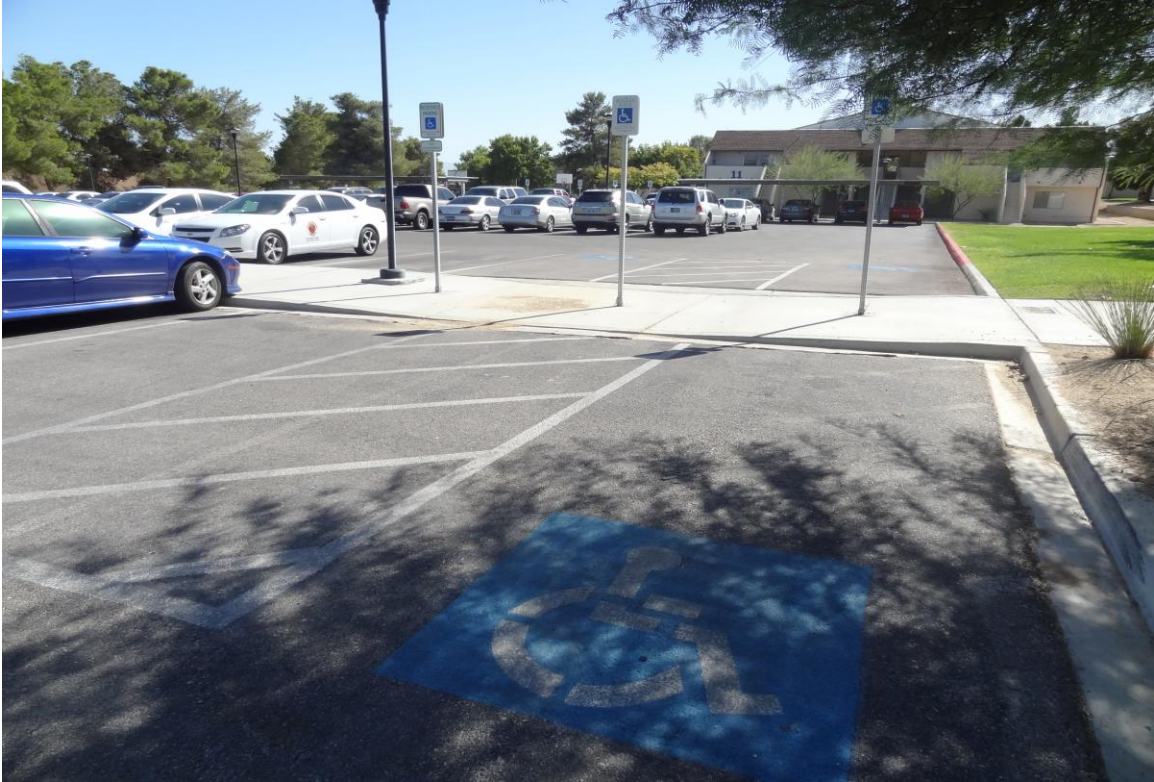
Southern Nevada Child & Adolescent Services Site – FCA Site #9991
Description: ADA accessible parking adjacent to Building 15.
